Cameretta d'ispezione

| Contratante | CAP HOLDING | Apertura | SI |
| | | Nota | CANALITTA IN GRES |

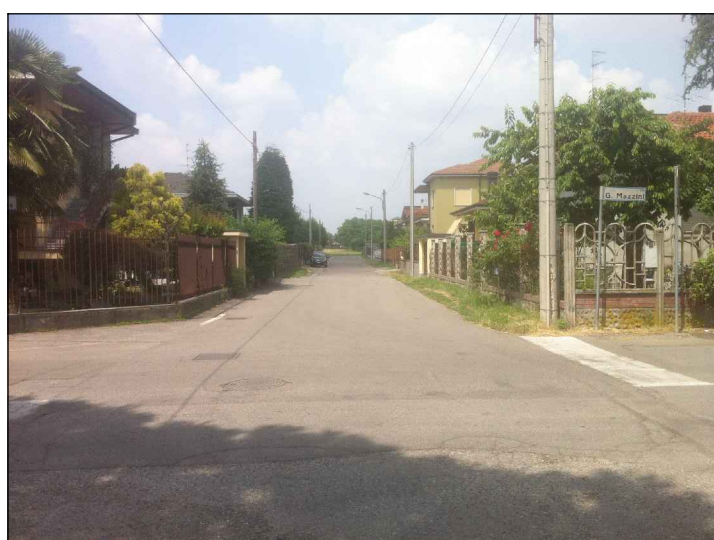
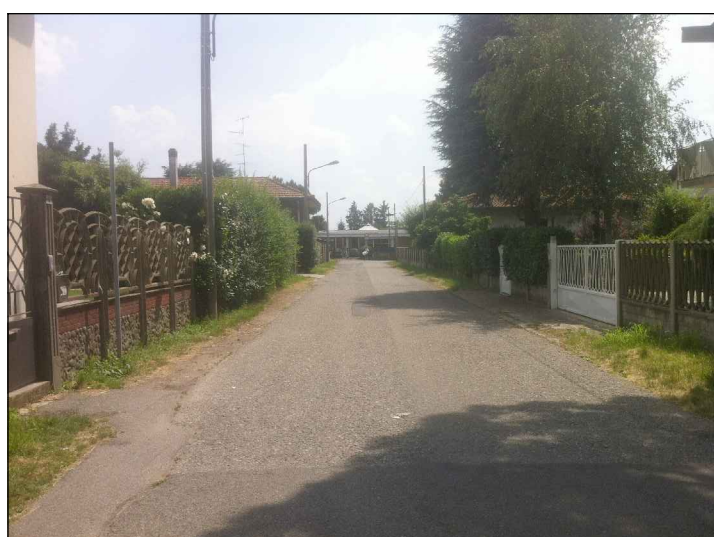
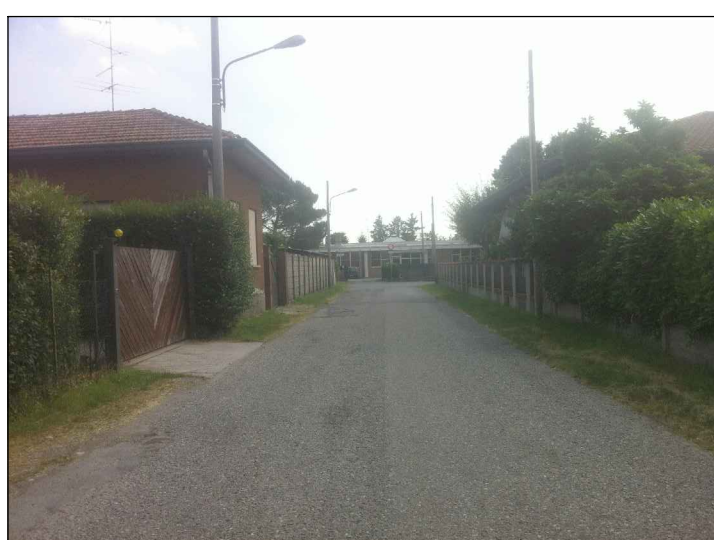
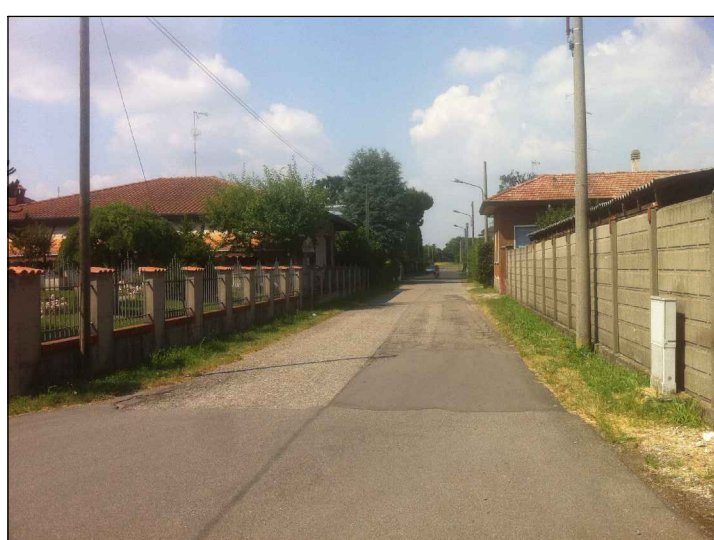
Indicazione Fotografia

Photograph of a road intersection. The image shows a paved road with a white line marking. A red traffic cone is placed on the right side of the road. In the background, there are trees and a building. The image is labeled with 'SANZIO' and 'VIA SA'.
